Hot Dip News Summer 2024 VETERAN

BRIDGE COLLAPSE EXPOSES THE DANGERS OF "WEATHERING STEEL"

January 28, 2022 – During the early morning hours of a snowy Friday, Pittsburgh, Pennsylvania was rocked by the unexpected: the massive structural failure of a commuter bridge located in the city's Frick Park. At approximately 6:30 a.m., the 447-foot bridge collapsed, falling over 100 feet to the ground below.

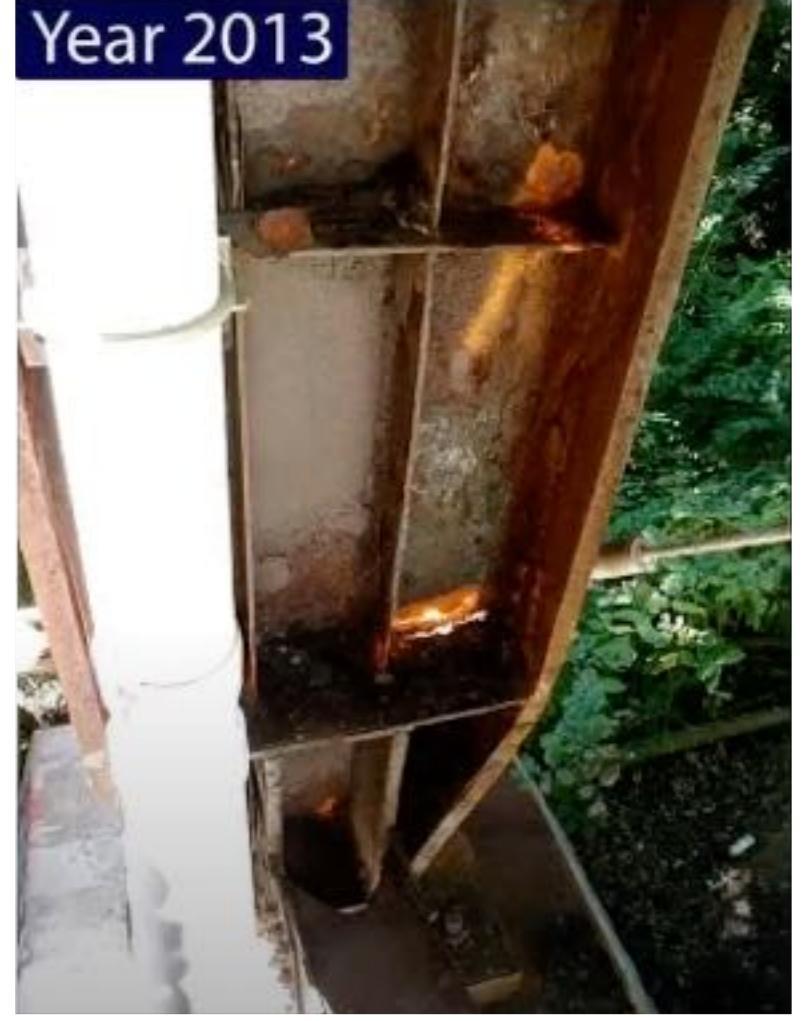
The bridge was deteriorating years before the collapse.

Analysis of steel structural elements of the bridge after collapse showed 50% or greater section loss in many areas, including some 100% loss where the steel had completely rusted away. This greatly reduced the weight-load capacity of the bridge.

Although repeated maintenance and repair recommendations were documented through years of inspection reports, the city didn't act on them, leading to continued deterioration of the fracture-critical transverse tie plate and the structural failure of the bridge.
